USB 3.0 Controller Driver Issues and Work Around Summary

Article ID: 359

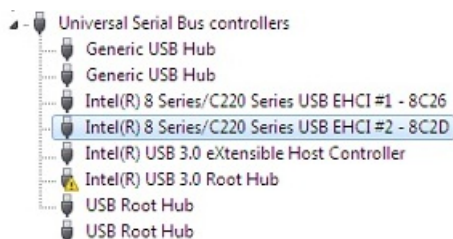
When you use the INF driver and deploy this through a driver package, the Intel 7 or 8/9 driver may not install properly. The "Intel(R) USB 3.0 Root Hub" is listed in device manager as an Unknown device, or with a yellow exclamation mark on it. Device Manager reports that the driver is not installed correctly.

The cause is a problem with the way the driver and driver ID is constructed. The device has an ID of USB3\ROOT_HUB30&VID_8086_PID_1E31 whilst the driver does not have an INF that matches closely enough for the deployment process such as WDS to use it.

- Reinstall the driver after the initial build of the system. This can be done either using the standard setup program, or, for larger scale deployments such as an SCCM build, use a task sequence and the silent setup option included in the [Stone USB 3.0 driver package](#).
- If you require that the Intel USB monitor program is not installed you can still use the INF only method after the operating system has been installed. To do this programmatically, use the drivers in the INF_Only folder and the `install.bat` file. This needs to be run with Administrative privileges.
